(Paper No. 2524.)

“Securing the North Cliff, Scarborough.”

By ROBERT AYTOUN, Assoc. M. Inst. C.E.

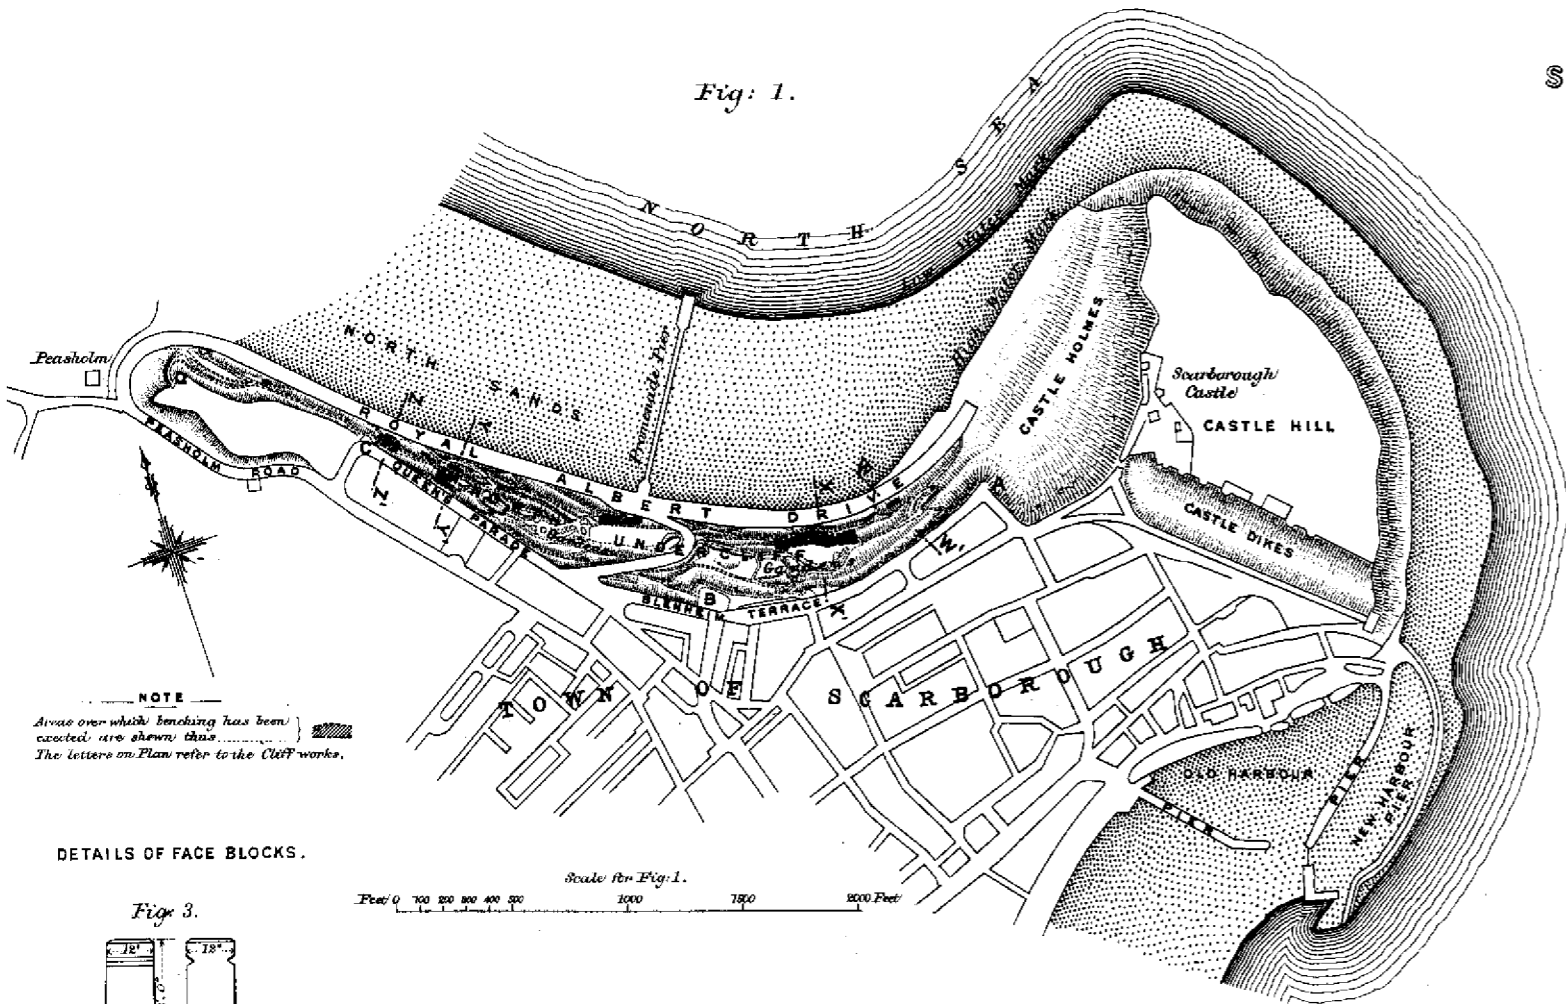
Fig: 1.

The rocks of the north cliff and undercliff belong to the middle and lower oolites. The main bulk of the undercliff from A to C (Plate 8, Fig. 1) consists of shale, mingled at intervals with irregularly bedded masses of sandstone. Above this lies a quantity of débris, from 10 to 30 feet thick, which has fallen or slipped from the adjacent cliff. The cliff, rising behind at varying elevations, is composed of boulder clay from B to D (Plate 8, Fig. 1), underlaid by the same estuarine rock as the undercliff (Plate 8, Figs. 8 and 9). From B to A it consists of sandstone, below which is a bed of shale covering a band of hard limestone—cornbrash—in all about 10 feet thick; and below the cornbrash is the upper estuarine series, of great depth, and forming the foundation of the whole cliff and undercliff (Plate 8, Figs. 6 and 7). The distinction between cliff and undercliff is less marked in the boulder clay, from B to D, than in the sandstone section, where the difference culminates at A in a precipice 120 feet high.

In the boulder-clay portion of the cliff, from C to B (Plate 8, Fig. 1), a longitudinal cutting was made in short lengths in the loose undercliff at the base of the cliff down to below the water-bearing beds, to prevent the percolation of water from the gravel beds in the cliff into the upper portion of the undercliff. Pipes were led up from the transverse drains already mentioned, and inserted in the solid cliff along the bottom of the cutting. Above the pipes, a rubble wall or screen, 18 inches wide at the base and 9 inches at the top, was packed against the side of the cliff; and the loose material of the undercliff was then banked against it, forming a buttress to the cliff and a protection against atmospheric destruction. The screen of rubble protected the made bank effectually from infiltration from the cliff, and also from the action of surface water from above.
